**Analysis of Environmental Impacts
Pursuant to the
State Environmental Quality Review Act**

**Project Name:
Project Fifi Proposed Warehouse and Distribution Facility
Town of Niagara, New York**

**Dated:
February 15, 2022**

**Submitted By: JB2 Partners, LLC
332 Grant Valley Road NW
Atlanta, Georgia 30305**

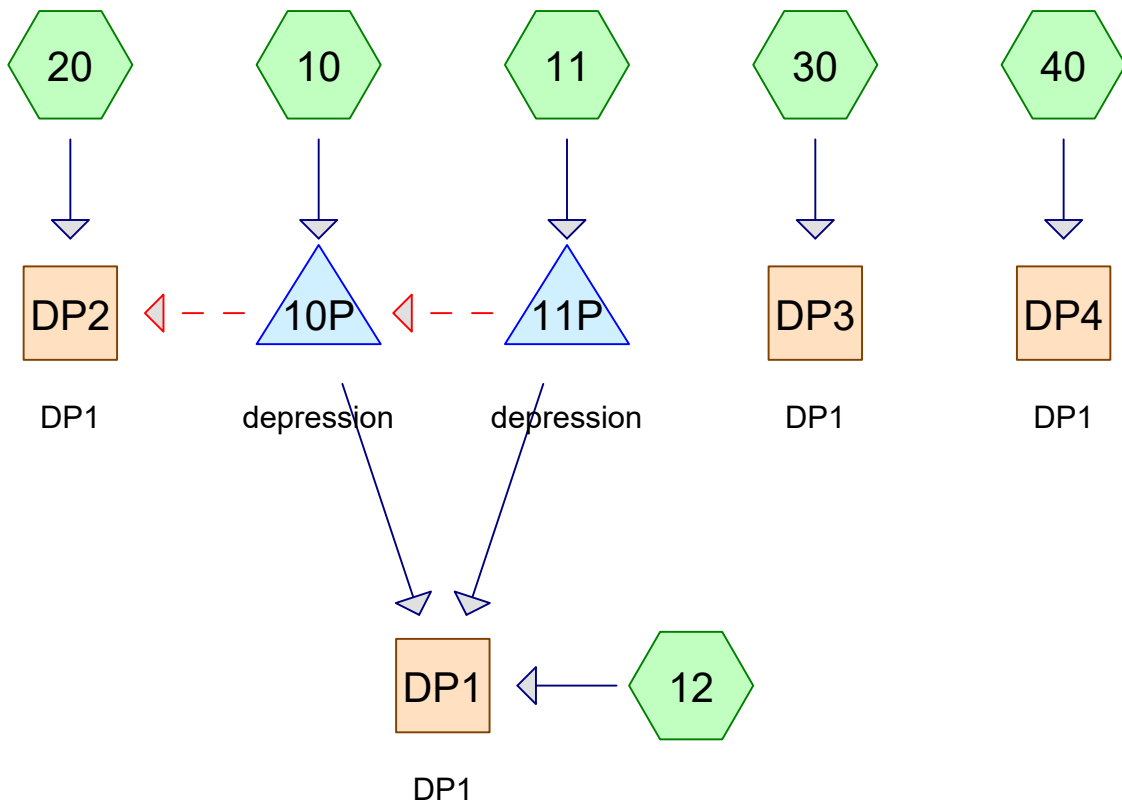
**PRE-DEVELOPMENT
 WATERSHED MAP**

Routing Diagram for 2022-02-15 Existing Conditions
 Prepared by Langan Eng & Env Svcs, Inc, Printed 2/11/2022
 HydroCAD® 10.10-6a s/n 11011 © 2020 HydroCAD Software Solutions LLC
